An Insidious Mode of Oxidative Degradation in a SiC-SiC Composite

Linus U.J.T. Ogbuji
NASA Lewis Research Center
Cleveland, OH 44135

Abstract

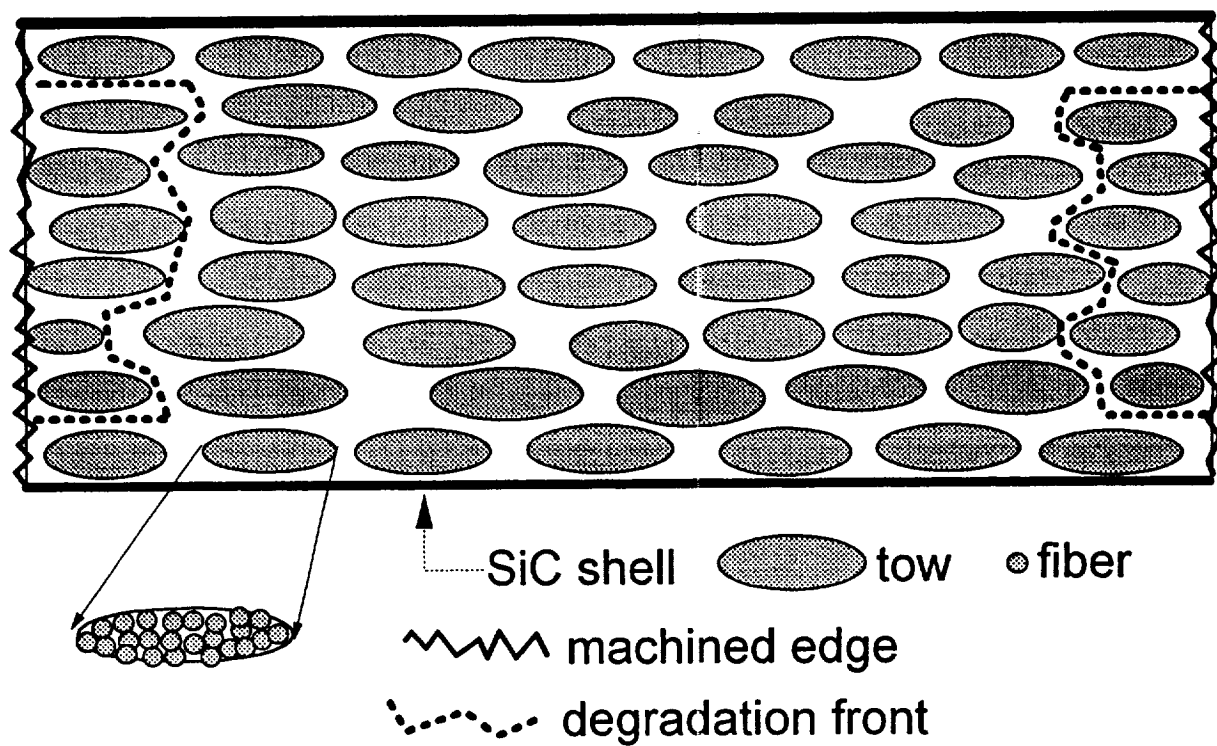
- Fig. 1 Schematic cross-sectional diagram of the SiC-SiC composite, illustrating degradation in a static ambient. Damage initiates at the surface and progresses inward, tow-by-tow.

Fig. 1 Schematic diagram illustrating the inward advance of environmental degradation, one tow at a time, expected (and often observed) in SiC-SiC composites.

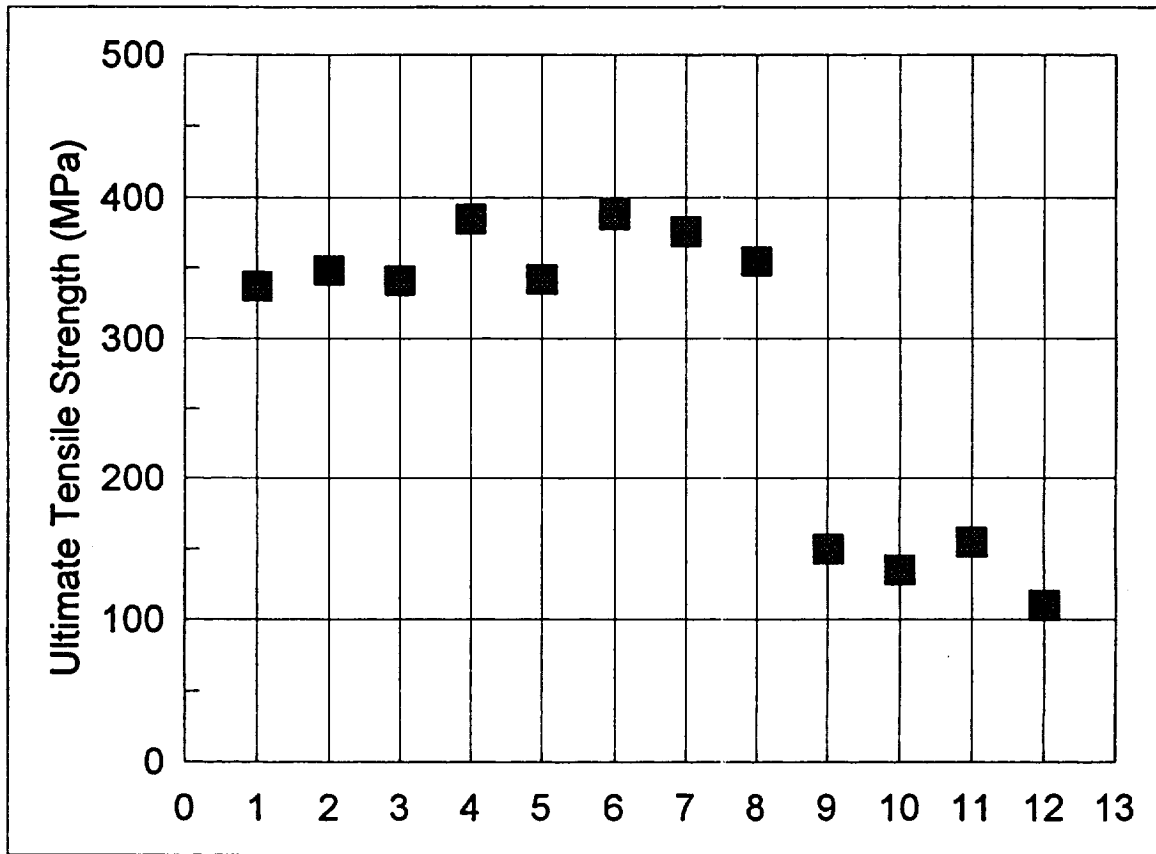
(1) The residual strengths and fracture strains of the SiC-SiC samples appear in Table 1, and the residual strengths are also shown charted in Figure 2. The relevant exposures of the samples are summarized in Table 1.

The differences of treatment or placement between the 4 burner rig samples is indicated in Table 1. A plot of the failure strains, not shown, was essentially identical to Figure 2. It is also clear from Table 1 that the trend of ϵ_f exactly parallels the trend of σ_u . The agreement between those two trends lends confidence to our interpretation of degradation effects in these materials. Clearly, the results fall into two categories. In the first category are the ultimate tensile strengths of the first eight samples, which are essentially the same and well within 15% of the as-received strength (of Sample 1). In the second category are the samples exposed in the burner rig (last four samples in Figure 2), which failed at 30-40% of the as-received strength. In other words, the material retained its strength after every furnace oxidation, but exhibited a dramatic drop in strength and fracture strain (60% and 90%, respectively) after a burner rig exposure.

It is apparent from Table 1 and Figure 2 that the role of H_2O content of the oxidizing ambient in promoting degradation is not straight-forward. This is clearer in Fig. 3 where residual strength is shown against moisture content. The sharp dip for the three burner rig samples (at 10% moisture content) and the apparent lack of a trend for the other samples clearly indicate an anomaly which is not attributable to moisture content alone. The trends indicate that, in the furnace oxidation exposures, the effect of increasing moisture content is minimal, while, in the burner rig, some other factor is contributing more than moisture content to the degradation. The close agreement in the results for all burner rig samples suggest that the factors that were varied in the rig (sample orientation the presence or absence of a nominal stress) had no significant impact on the degradation. We note, also,

- Fig. 2 A chart of residual strength of SiC-SiC bars: as received (# 1), and following oxidation at 800°C in room ambient (#s 2,3) or in 30% H_2O +70% O_2 to 90% H_2O +10% O_2 (#s 4-8), or in a Mach 0.3 burner rig (#s 9-12). Only the burner rig caused significant loss of strength.

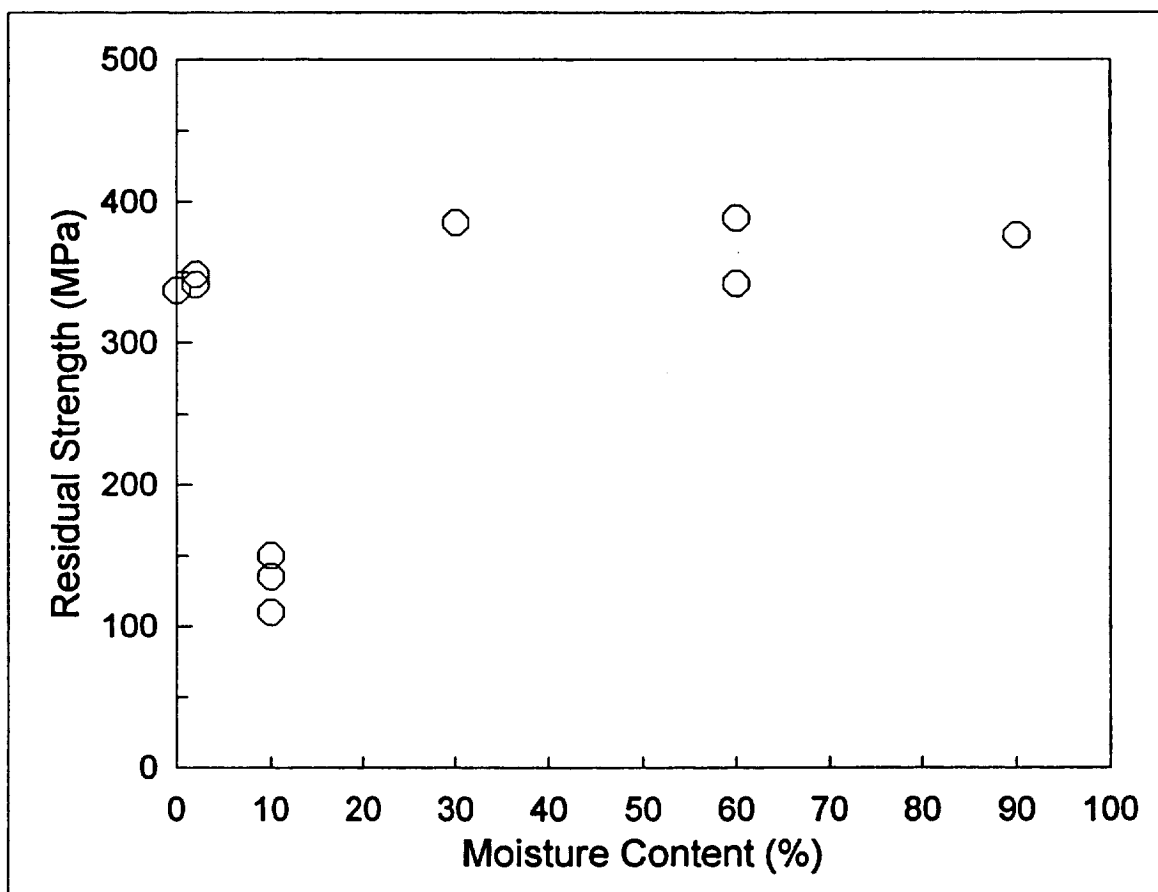
- Fig. 3 A chart of the same results as residual strength versus ambient moisture content. Again, the only significant strength loss occurred in the burner rig (10% moisture).
